PARTS ON DEMAND LIMITED

TECH TIPS April 2004

Optra S Image Problem

FUSER ERRORS (50.x) IN THE HP8100/HP8150

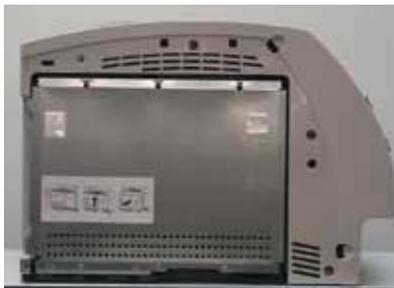
This small plastic disc is part of a larger mechanism that drives the drum, and a vital part at that. This mechanism is called the developer drive assembly and is located on the left-hand side behind the printer's controller board. (Figure 1). The developer drive consists of three gears; one contains a spring-loaded shaft that engages and disengages the developer drive coupler. (Figure 2a.) This coupler meets with a small wheel on the left-hand side of the toner cartridge allowing the image drum to rotate. (Figure 2b.) The coupler moves into the printer to engage the drum when the top door is closed and disengages when the top door is opened. But how does a defective drive assembly cause the image to fade in and out and never in the same place?

Figure 1. The developer drive is located on the left side behind the printer's controller board.

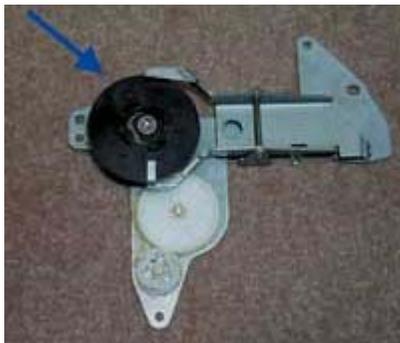
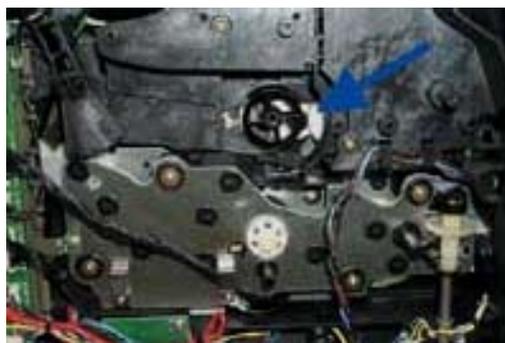
Figure 2a & 2b. The black wheel is spring-loaded and engages and disengages with the hub on the toner cartridge.

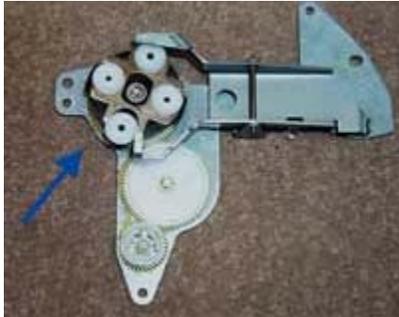
The developer drive coupler consists of four white plastic discs, the ones mentioned earlier that enable the coupler to engage with the cartridge evenly. (Figure 3.) If one of these discs is missing, the image drum rotates disproportionately. This uneven rotation causes the left side of the toner cartridge to lift slightly, producing a gap between the image drum and the transfer roller. Therefore, the image on the drum does not transfer completely to the paper, and the end result consists of light areas down the left-hand side of the page. (Figure 4.)

Figure 3. The drive coupler that engages with the toner cartridge contains four white plastic discs, which rotate the toner cartridge evenly.

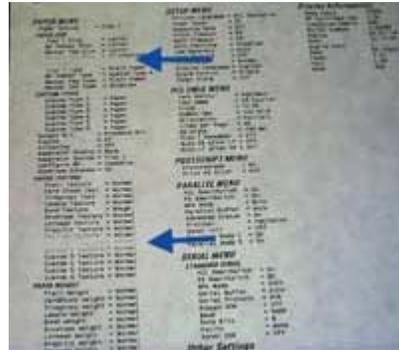
Figure 4. This is an example of the image defect with a missing disc. Since the drum is rotating disproportional, the end-result is poor transfer.

Before I discovered the missing disc, this problem had me perplexed, since the transfer roller or high voltage power supply cause most transfer problems. I never would have suspected the developer drive assembly, since defective cartridge drive assemblies, on most laser printers, usually leave horizontal lines down the page, cause paper jams or do not print anything at all.

The solution to this problem is to replace the developer drive assembly since the discs are unavailable. The part number for the developer drive assembly is 99A0135.
