CKT-BNC Contact & Dielectric Detail
Drawing CKT-BNC77-RG58-CASA.PRT

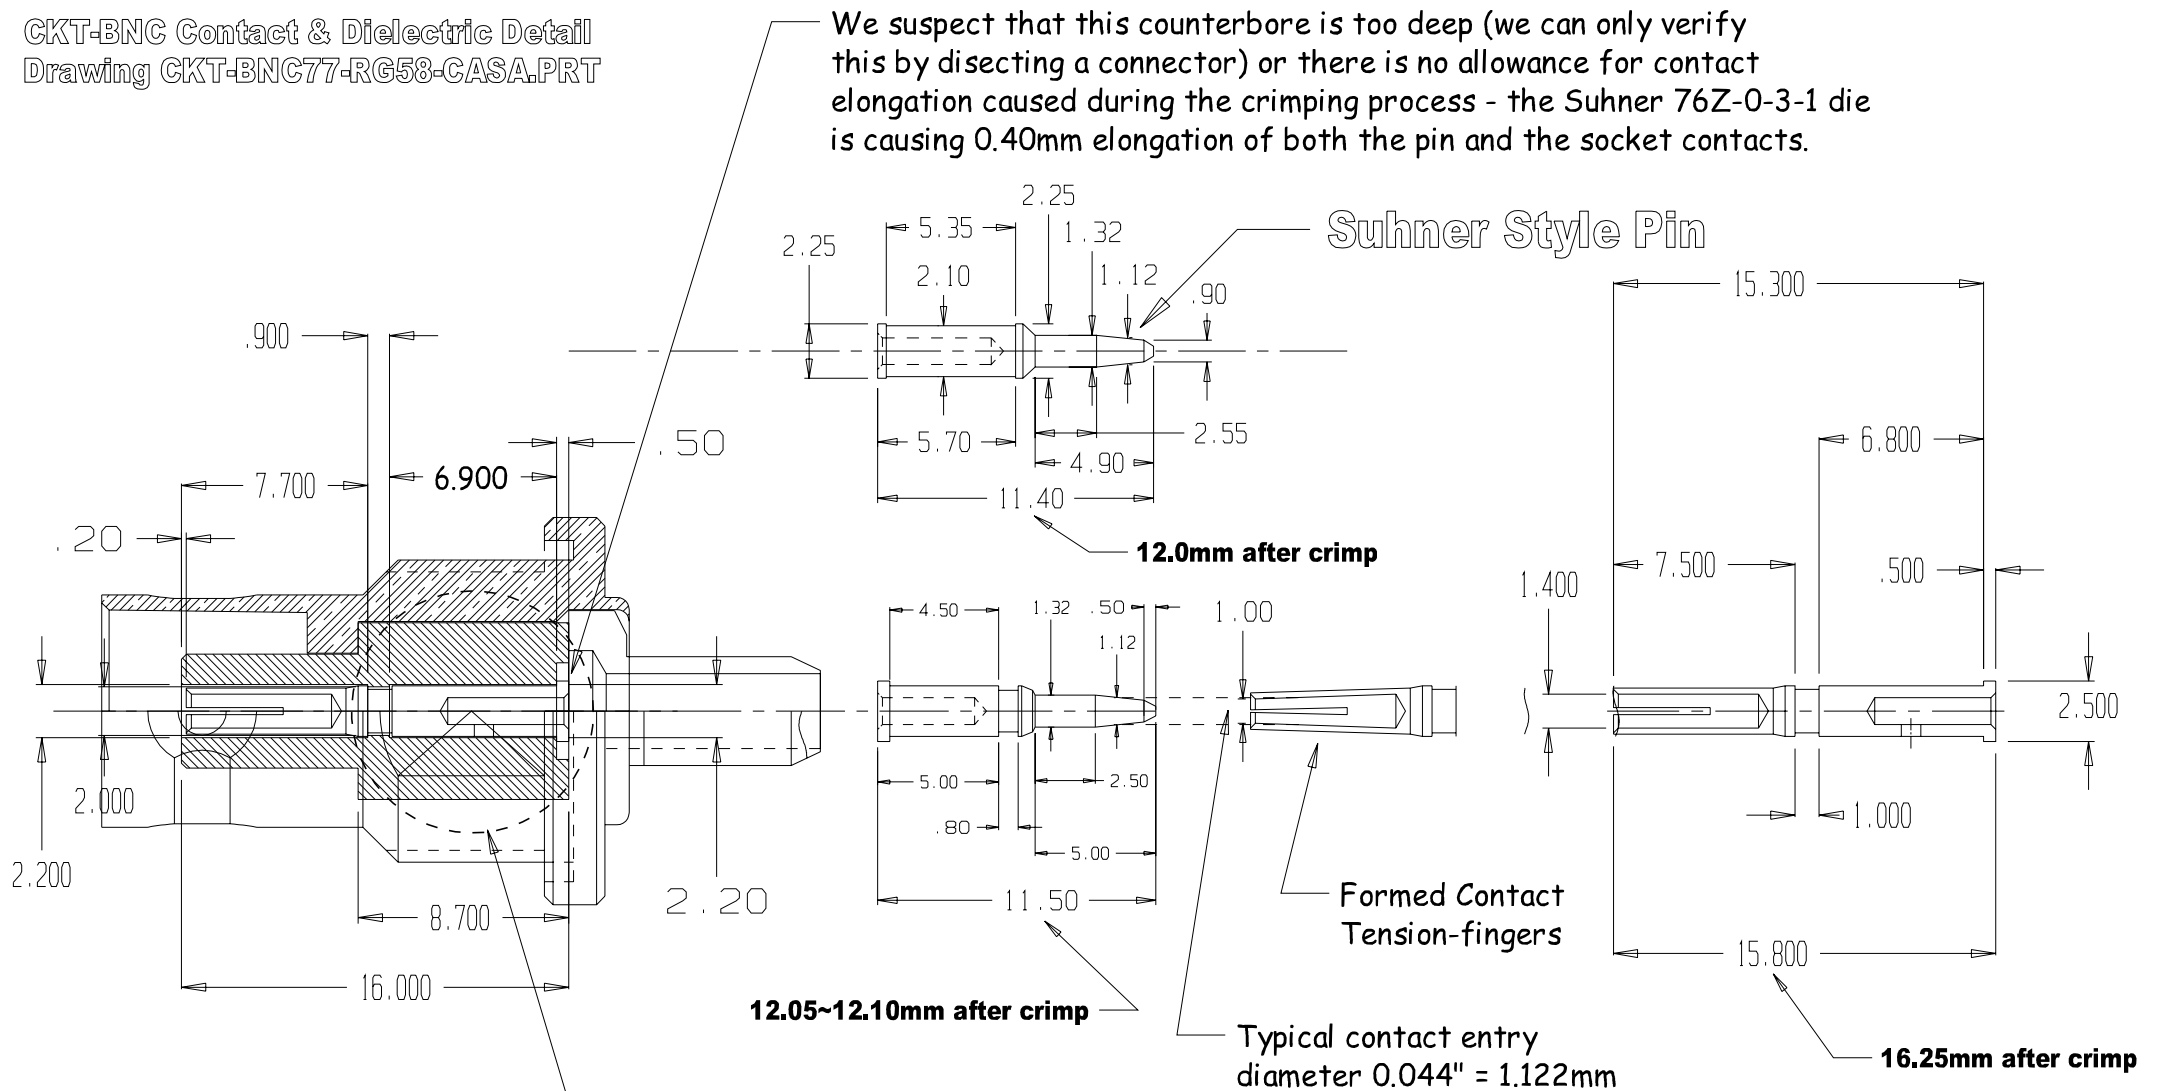
This is the suspect region of error causing 'spring-back'. We conclude that the 6.90mm (showing here) must be smaller in production parts and is allowing the contact to push past the 0.9mm capivation ring.

NOTE - suitable allowance may need to be made for the elongation of the contact caused in the crimp process. Typical elongation 0.4~0.5mm has been measured in tests with Suhner 76Z-0-3-1 die-set.
