# **The effect of rope termination on the performance of polyester mooring ropes for marine applications**

## **Abstract**

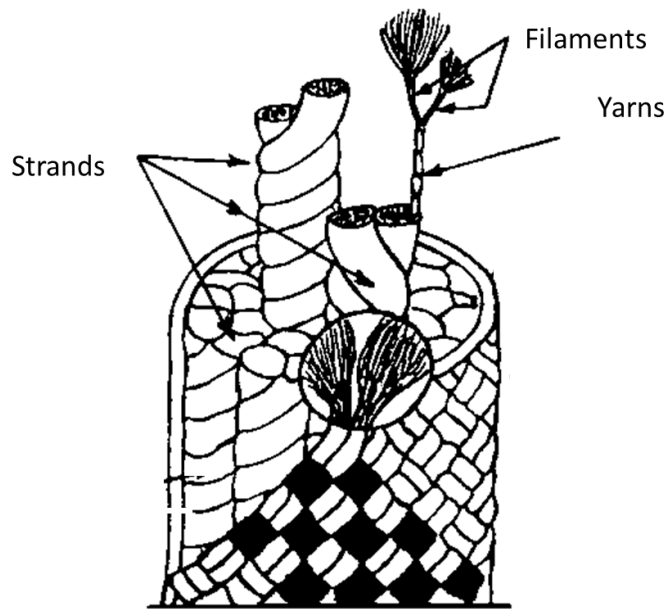
Fig.1. Schematic diagram of rope construction [Natural Disaster Organization, 1996].

The construction of strands involves a twisting process of filaments whereas the sub-ropes used in this study are made by braiding the strands to form sub-ropes. The braiding process inherently restricts the extension under load, therefore the resulting elongation is reduced in relation to the tightness of the braiding structure.

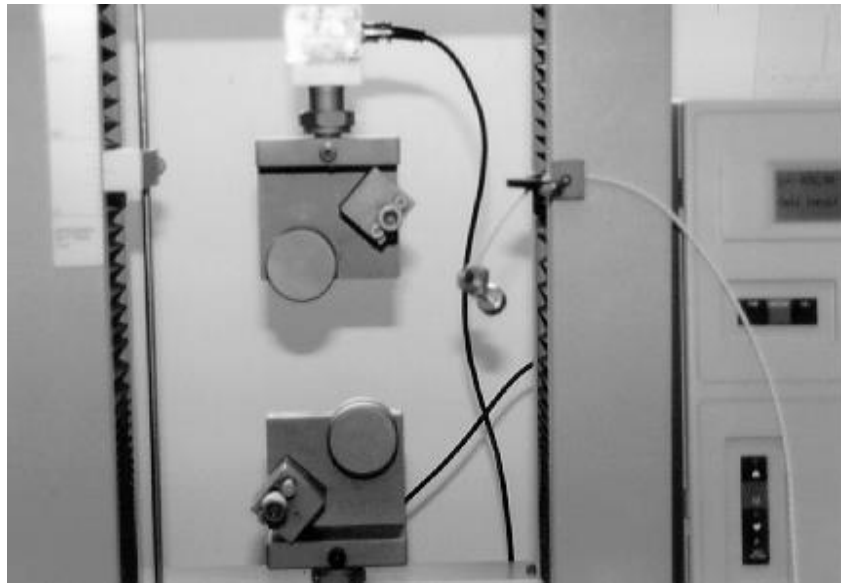
Fig. 2. 5 kN Lloyds Machine used for tensile testing of filaments, yarns and strands.

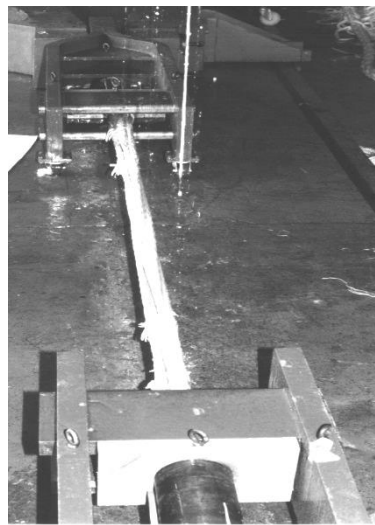
203  
204 Fig.3. 44mm rope mounted in the 1500kN tensile machine used for rope testing.

180 The Digital Monitor 1500kN tensile machine was used to test the 44mm diameter ropes, as  
181 shown in Fig.3. In each case, 12 samples were tested. The testing machine was assembled in  
182 Bridon Marine, with a load cell of 1500 kN. The digital monitor locks on the highest value at  
183 failure load. Three methods of termination were used for 44mm rope, namely splice, Parafil  
184 socket and stress relief socket. To hold the assembly sockets, especial adapters were made, as  
185 the original setting could not accommodate the assembly socket. For splice, the rope comprised  
186 of 7 individual sub-ropes. Each sub-rope was spliced as an individual rope. The only precaution  
187 to follow was that each sub-rope should not be inserted into its own body because if it happens,  
188 the splice eye would bulge. Thus, when each sub-rope was spliced, pieces of rope were tied  
189 around the complete rope to keep the splice together. Viking7 socket, as shown in Fig. 4(b), is

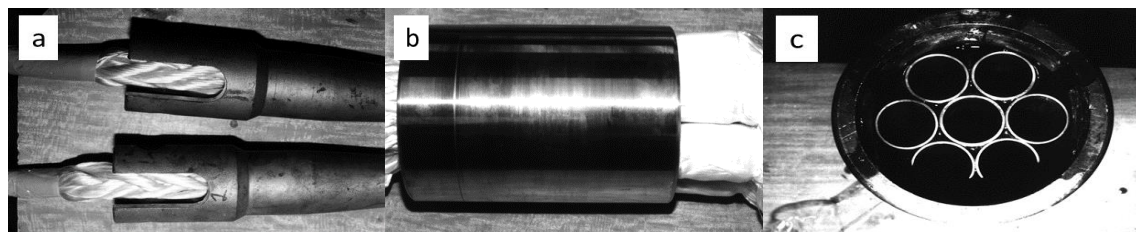
205  
206 Fig. 4. Photographs of different termination with rope (a. Parafil socket, b. Viking 7 socket, c.  
207 stress relief socket)

190 an enlargement of Parafil socket for 44mm rope because there is no socket for that size of the  
191 rope. For stress relief socket, shown in Fig. 4(c), is a new design, which incorporates  
192 reinforcement of material inside the socket. In this process, the design of Viking7 socket was  
193 changed to include extra reinforcing material. Fig. 5 shows a cross-sectional side view of stress  
194 relief socket, which includes bore, housing member, frusto-conical outer surface, frusto-conical  
195 outer surface, frusto-conical chamber, wedge member and hollow members. The internal

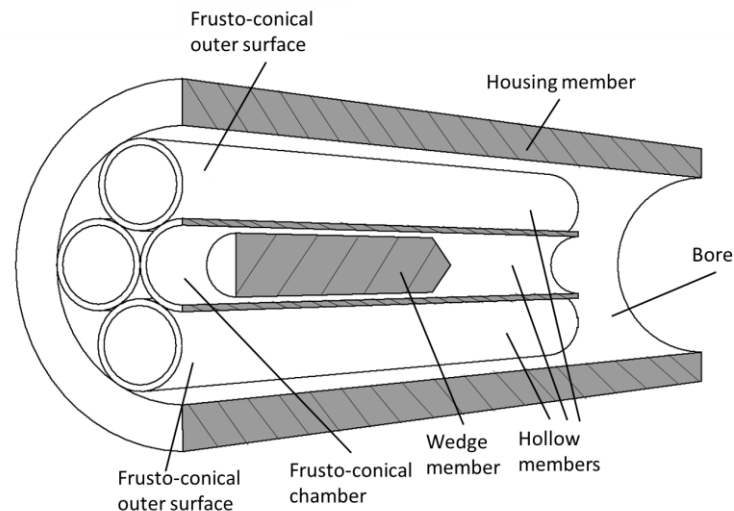
Fig. 5. A cross-sectional side view of stress relief socket.

196 volume of the socket was increased although the same spikes were used. Both socket  
197 assemblies were covered with a large heatshrink. Resin was added on top of both sockets to  
198 lock tight the fibres from any movement. The initial length of the sample was measured, before  
199 the final load application, a pre-load of 100kN was applied to remove any inhomogeneity in  
200 the individual ropes. Then, the sample was loaded to break and the final breaking load was  
201 recorded from the digital monitor. A total of 12 samples were used to test each termination  
202 type.

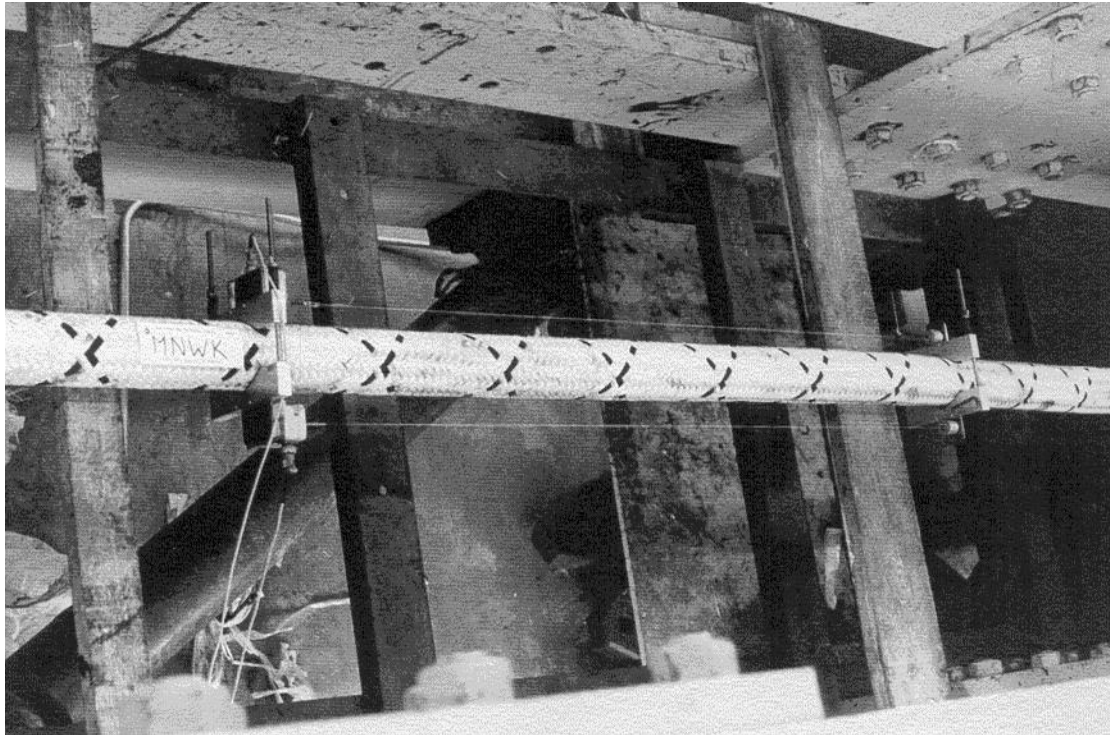
Fig. 6. The 120mm rope mounted in NEL 30MN tensile machine.

In order to test the 120mm rope, the 30MN machine from NEL (National Engineering Laboratory in Scotland) was used, as shown in Fig. 6. This was a 30MN horizontal two-space servo hydraulic-testing machine. Eight hydraulic actuators applied a uniform force to a common moving crosshead. The applied force was derived from the summation of the transducer output and display on a digital voltmeter scaled in increments of 1 mV equivalent to 10kN. A full-scale reading of 3 volts corresponded to an applied machine force of 30MN. The procedure was the same as that for 44mm rope. However, because of the increased rope diameter, everything has been scaled up to 120mm. The initial length of each sample, stress drop during 30min holding time, extension under different loads, and breaking load were monitored by a computer.

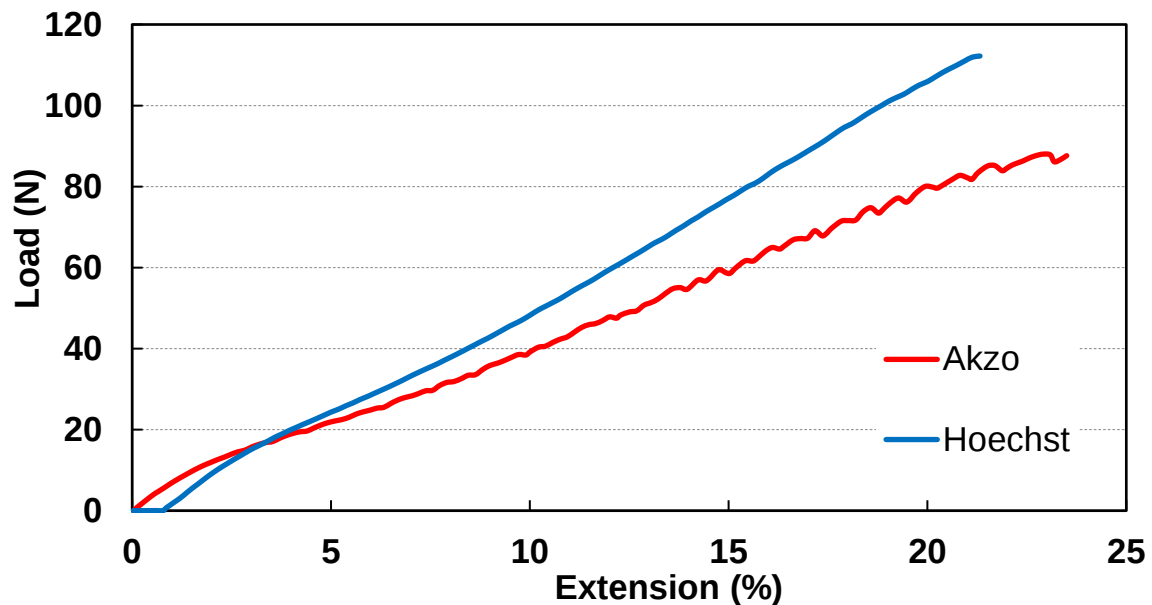
Fig. 7. Typical Load-Extension curve for Akzo and Hoechst filaments.

The effects of varying extension for Akzo and Hoechst filament with different load were measured and plotted, as illustrated in Fig. 7. There is no knee region shown in both curves. Therefore, they were divided into two main parts, an initial non-linear stage, and a linear behaviour up to the break. A non-linear region for both materials started from the initial stage of load application up to 20 N and 5% extension. This non-linearity in the initial region is due to both a molecular chains reorientation within the fibres, and a reorientation of the fibres in the filaments (Davies et al., 2011) and (Bunsell, 2018). Beyond this region the curve becomes linear. The oscillations on the lateral part of loading curve in Fig 7 for Akzo filaments indicate the progression of damage resulting from fibre abrasion. The damage is caused by abrasion of filaments as a result of fibres rubbing against each other. However, the special, low friction coating on the Hoechst fibres mitigates abrasion, the curve does not show oscillations and hence prove to be more superior in achieving higher breaking load.

Comparison of Fig. 7 and 8 indicates some important differences in the performance of the two materials. Akzo filaments contain about 60% more fibres than Hoechst but the breaking load for Hoechst filaments is 34% higher than that of Akzo filaments. This is due to the superior abrasive resistance coating of Hoechst fibres. However, when the strands are considered the loading performance of Hoechst strands (BL=11kN) is only about 10% higher than that of Akzo strands (BL=10 kN). This is because Akzo strands contain 16570 fibres whereas Hoechst strands contain 15860 fibres, ie Akzo strands contain only 4.5% more fibres than Hoechst strands. Therefore the effect of surface coating is much less pronounced in strands.

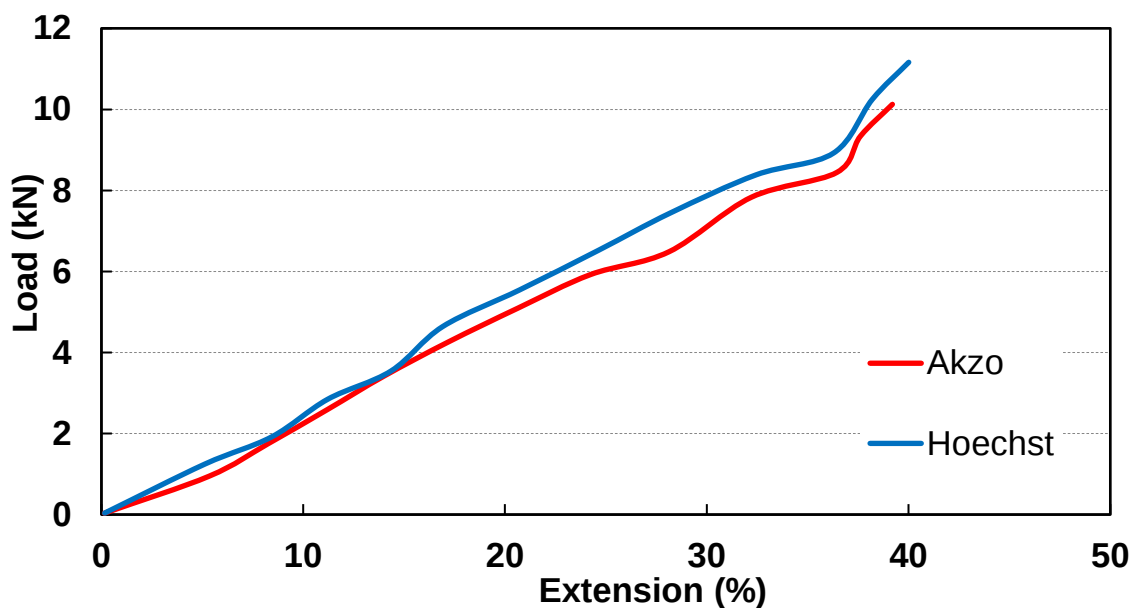
Fig. 8. Typical Load-extension curve for Akzo and Hoechst strands.

In addition, the effects of extension percentage of Akzo and Hoechst strands at the different applied load have all been measured and presented in Fig. 8. The dominating effect in tensile properties of strands, compared to single filament, is filament twisting, as strands are made of twisted yarns. As the load increased, the friction between the fibres leads to an increase in the heat generated. The heat will cause the fibres either to fuse together or become very compacted (Leal et al., 2017). There is a relative decrease in the rate of tenacity in both materials at similar extensions before they break which happened around 32% to 36% extension. There is a decrease in the loading properties when filaments melt. When melting, filaments tend to fuse together and behave like a uniform bar that result in increase in the final breaking tenacity. The slight irregular behaviour of the curves up to 15% extension relates to the filaments' alignment during loading and the seeming oscillation pattern towards the end of the curves indicate the

extent of premature damage and failure in the individual filaments or a group of fused filaments. During the test some cracking sound was noticed before the final break. This would substantiate the oscillation or deviation of both curves from linearity towards the end during the tests. It can be seen that Hoechst strands undergo more realignment earlier in the deformation, less filament failure towards the end and superior breaking load. This is contributed to the special coating on the Hoechst filaments.

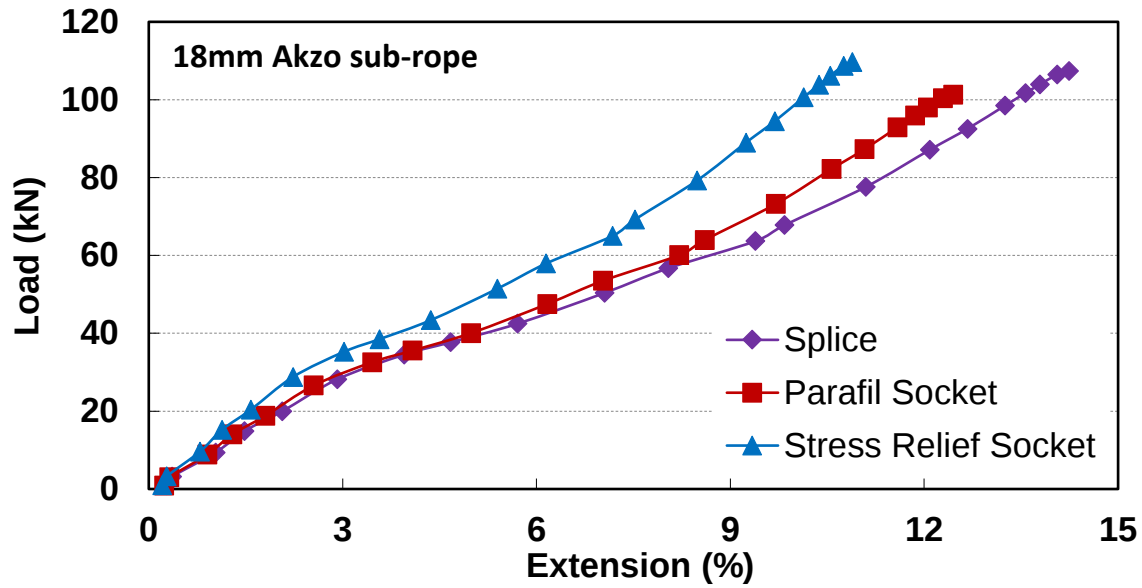
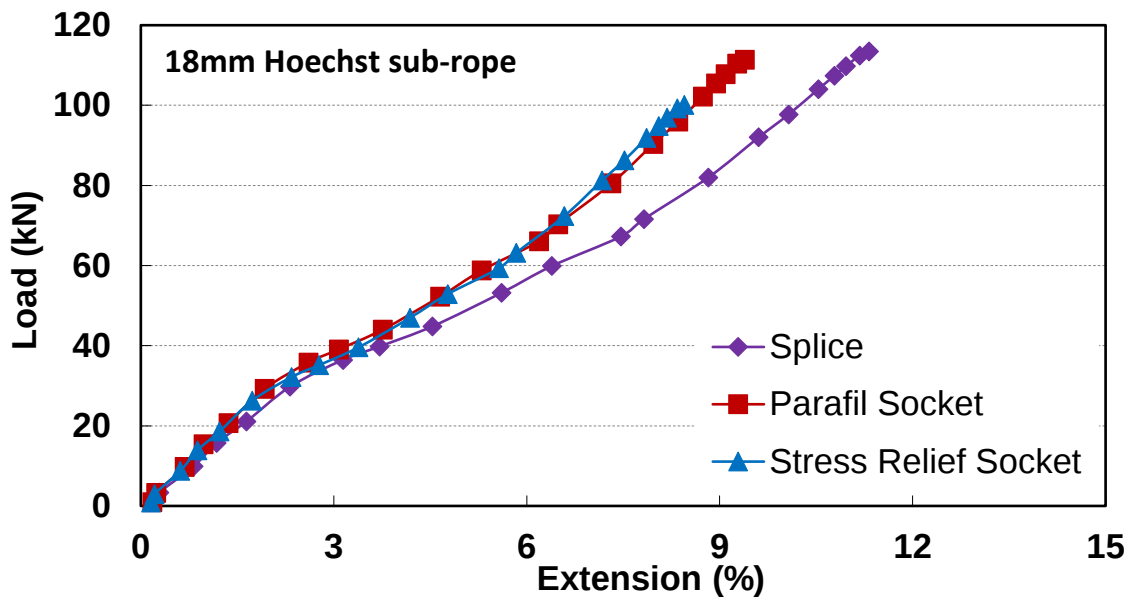
Fig. 9. Load-extension behaviour of 18mm Akzo and Hoechst sub-rope tested with different termination type.

The tenacity-strain figures of the Akzo and Hoechst sub-ropes with different termination methods are graphically shown in Fig. 9. Comparison between both materials, suggests that the rope tenacity for the splice termination is less than those of Parafil and the Stress Relief sockets. The results indicate that Stress Relief Socket performs less favourably when Hoechst ropes are used; the load-extension profile of the Hoechst material in relation to splice termination is lower than that of Akzo. This is due to the application of a special coating which has been found to be incompatible with the polyester resin used in the socket to reinforce the fibres inside the socket. Whereas Akzo materials do not use any coating and therefore leads to better bond strength to the resin.

Different termination methods have various effects on the extension to failure of sub-ropes. The extension to failure of rope using the Parafil socket was higher than that in the splice while using the Stress Relief Socket appeared to produce the lowest extension in ropes. It should be noted that extension in the Parafil and the Stress Relief socket is a combination of the socket-draw and rope extension, while in the splice slippage happens in the buried parts of the rope. It

appears that the slippage in splice is smaller than the socket draw in the Parafil socket. The least rope extension occurred in the Stress Relief Socket. The main reason for this lower deformation is due to the use of extra reinforcing material within the socket, which caused fibre locking, resulting in lower extensions. In addition, the smaller socket-draw in the Stress Relief Socket is due to the stiffer and larger volume of fibre assembly inside the socket because of the extra reinforcement used. Moreover, the extension has been shown to be dependent upon the material type. The Akzo sub-rope extended 30% more than the Hoechst sub-rope under tensile loading regardless of the termination method used. The use of the Hoechst fibres in the Parafil socket led to slightly larger extensions when compared with the splice and the Stress Relief Socket.

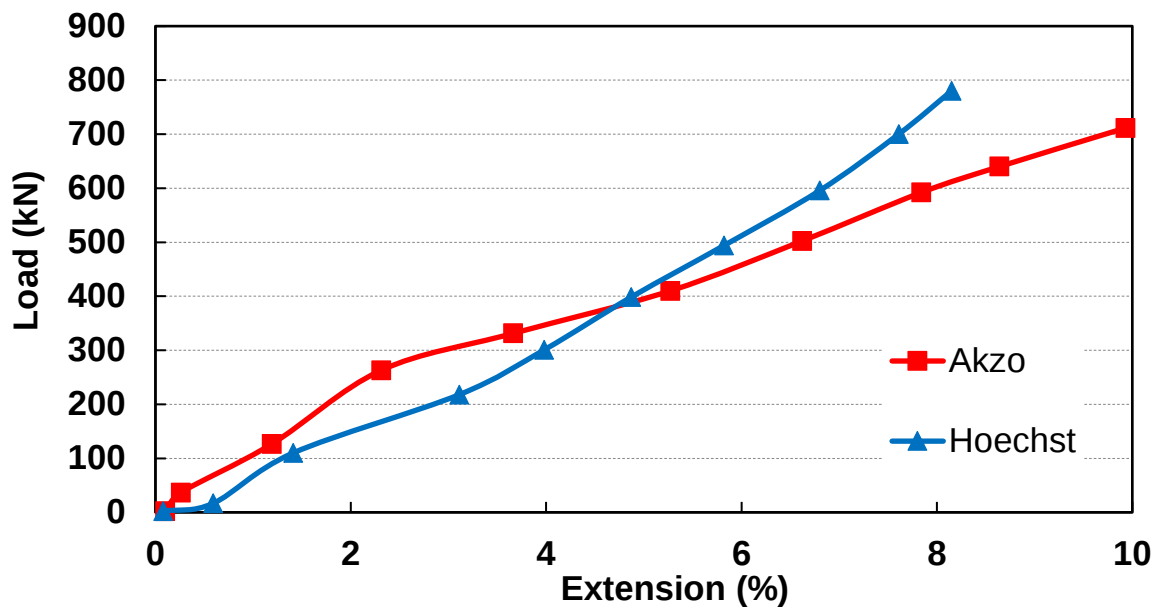
418  
 419 Fig. 10. Typical load-extension behaviour of 44mm Akzo and Hoechst rope tested with Stress  
 420 Relief Socket.

To compare both materials in the Stress Relief socket, a typical load-extension behaviour of the 44mm Akzo and Hoechst ropes was recorded and is shown graphically in Fig. 10. The Akzo curve showed a clear knee point before complete linear region while Hoechst tenacity pattern

414 did not illustrate the same pattern before linear region to failure. As mentioned previously,  
 415 Hoechst used a special proprietary surface coating which reduces abrasion in the fibres. This  
 416 potentially reduces damage to the fibres and therefore leads to a more linear load-extension  
 417 behaviour. This explains the reason why there was no clear knee point in the Hoechst curve.

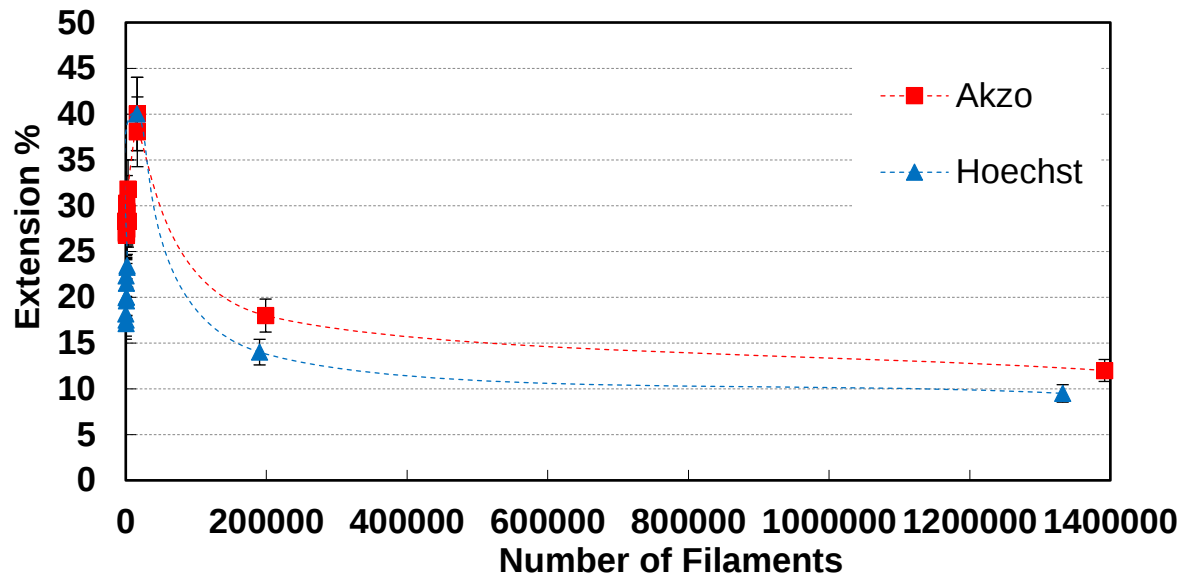
Fig. 11. Extension percentage at break for different number of filaments of Hoechst and Akzo materials.

421 The maximum extension at break for different constructions of Hoechst and Akzo materials  
 422 including filament, yarn, strand, 18mm sub-rope and 44mm rope is shown graphically in Fig.  
 423 11. The results show that the maximum strain to failure is the same for all the small size  
 424 filaments up to the strand construction. There is a sharp rise in the strand. This is due to the  
 425 inherent increase in the twist in the construction. The reason for this phenomenon is that during  
 426 the initial stages of loading, a significant proportion of the extension consists of untwisting  
 427 before complete loading is taken up by the filaments.

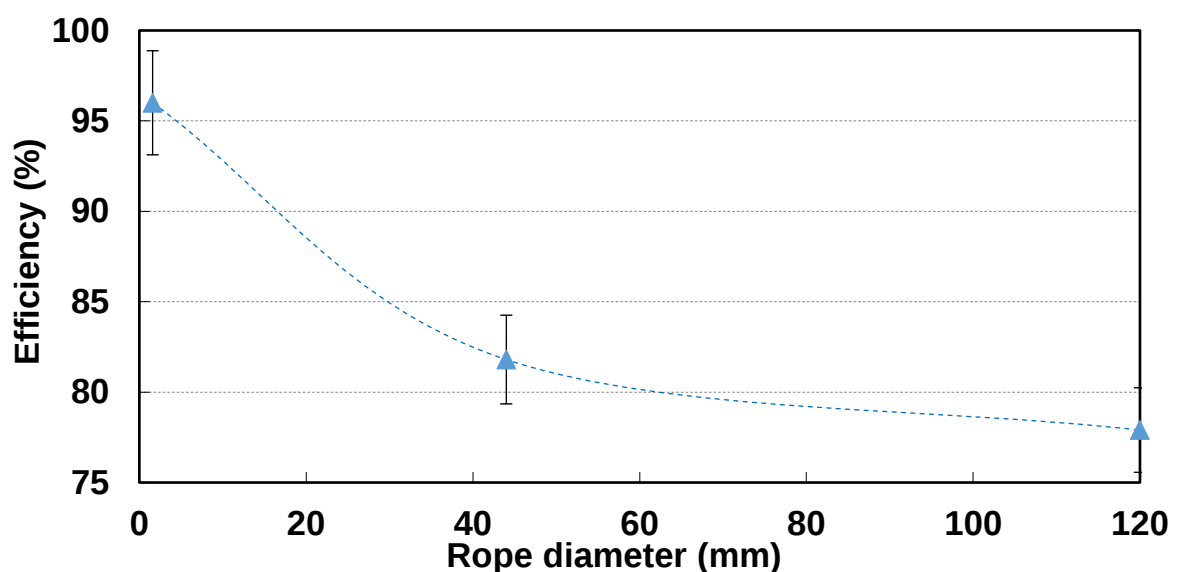
Fig. 12. Tensile efficiency drop by rope diameter using the Stress Relief Socket.

The rope manufacturers usually consider at least a 50% reduction in the rope efficiency from filament to rope. Although 50% reduction might not be an acceptable figure for safe working condition, it is a proper method to show the capability of the rope and the advantage of termination over the other methods. The post-mortem examination of the rope indicated that 2 sub-ropes were still intact. Having some unbroken sub-rope indicates that a higher breaking load is expected if more care is taken in sample preparation and arrangement of the materials in the socket. Considering the first test on this rope with this termination and some unbroken sub-ropes, the results are promising and further work on this method is recommended.

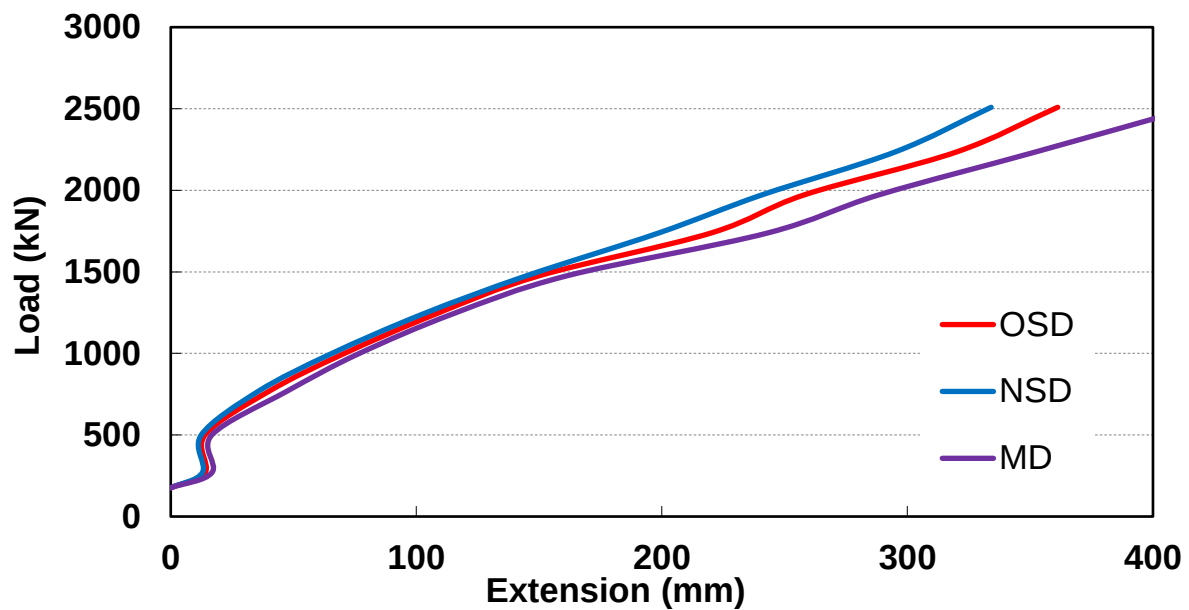
Fig 13. Typical load-extension profile for the 120mm rope samples. (OSD= Offside Displacement transducer; NSD= Nearside Displacement transducer; MD= Machine Displacement).

To measure the socket-draw and investigate the tenacity behaviour of the rope, three separate extension measurements were taken. These included machine displacement, i.e. face-to-face displacement of sockets as well as using two independent displacement sensors, namely nearside displacement (NSD) and offside displacement (OSD) transducers. Fig. 13 shows the load-extension curve for the 120mm rope sample with the transducers attached to the 2m gauge length of the rope.

The extension measurement was intentionally delayed by applying a preload of 500 kN to remove the effect of sub-ropes misalignment. Thus, when the pre-load is initially applied the alignment of sub ropes takes place and therefore no deformation of the rope material is expected during this period. This is indicated as a sharp rise in load with no change in displacement between 250-500 kN, the rope response is mostly structural in the initial stages of loading.

It can be seen that as the load increased, the machine displacement increased at a faster rate than the other two transducers. This is because the machine displacement is a combination of the machine stroke, socket draw, and rope extension while the transducers show rope extension only. The rope, as a textile structure, reacts to an applied stress with a combination of structural and material deformations. Its deformation, thus, depends on the structure of the fibre materials used. As a rigid structure, 120mm rope behaves like a metal bar when the load is fully transferred to the sub-ropes.

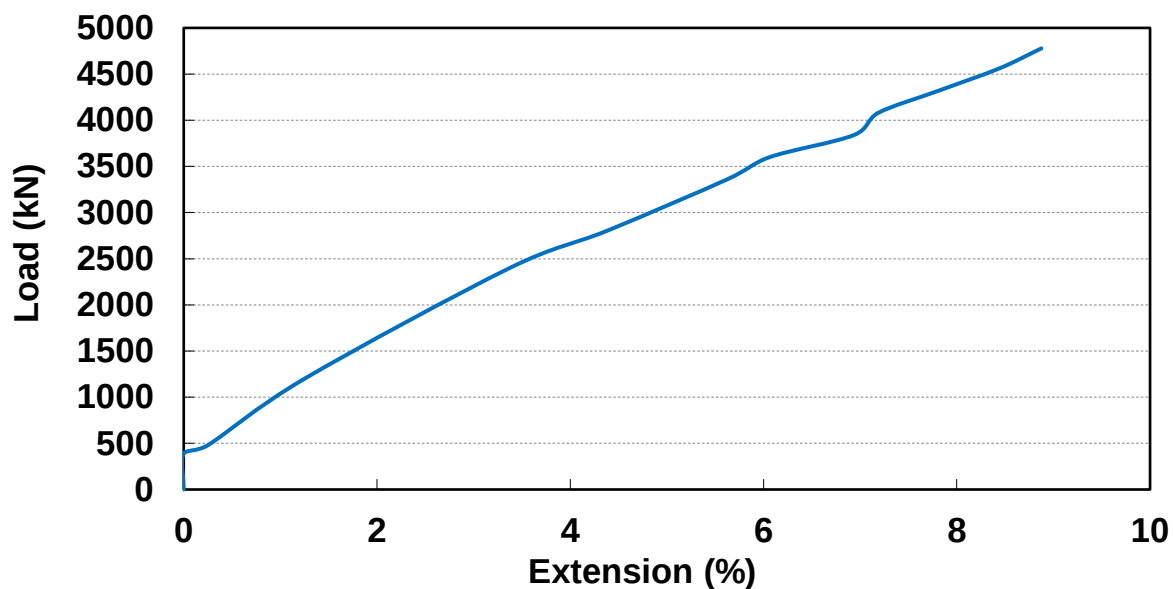
Fig. 14. Typical Load-Extension curve for 120mm rope.

The load-extension curve for 120mm rope until final break is presented in Fig. 14. The sample broke at 4778kN. Partial failure took place with two sub-ropes still intact. There is no clear knee point in the profile. Because most of the fibre realignment and socket-draw were removed

in the previous cycling and tensioning processes. When the rope was made, it was expected that most of the fibres realignment is removed under the sub-ropes tension. Slight fluctuation in the graph around 3700kN is due to the progression of microdamage/ premature failure of subcomponents. The total extension in the rope was measured at 150.39mm. Socket face to face length after initial cycling was measured to be 334.22mm at 2500kN. A simple comparison between these two figures, indicate that most socket-draw and fibre realignments are removed during the loading regime before final break. Therefore the resultant extension is considered to be the actual extension of the rope excluding fibre realignments and socket-draw.
