## TECH TIPS May 2004

## **50 Errors on the HP4100**

**ERRORS IN THE HP LASERJET 1150/1300/1300n**

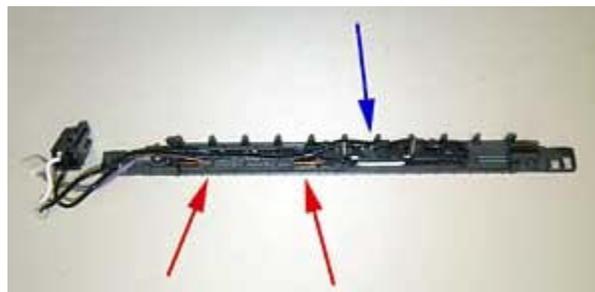
The 4100 fuser is a more complicated device, as the ubiquitous "50 service" error message indicates. Along with three separate heating elements in the fuser, there are two thermistors (temperature sensors), and one thermo switch ( temperature protection switches). Position of these is important to record correct temperatures for the different elements. Figure 1 shows the positioning of the thermistors and thermo switch on top of the three-element ceramic heater of the 4100.

After examining some of the failed fuser units, it appears the thermo switch causes the "50 service" errors. This thermo switch in the 4100 fuser is highly specialized and can only be found as a part of the 4100 fuser film assembly. Although a replacement fuser assembly seems like a quick fix, it isn't. Replacing the fuser with a new one caused the same error message to appear after a few days in some instances. We came across some customers who were on their fifth or sixth fuser and getting frustrated with the reoccurring error message.

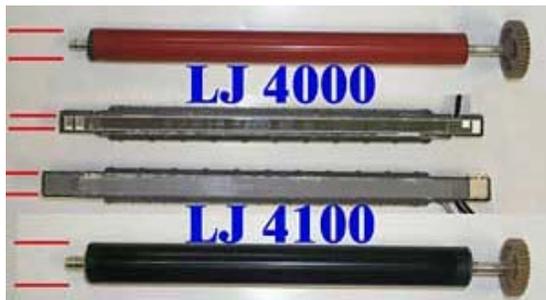
Figure 2

Since that time, HP did come out with a new version of the 4100 fuser and not only fixed the "50 service" message problem, but also made another nifty improvement.

If you remember, when the 4100 was first introduced, many customers were complaining about crease marks in the paper. These crease marks were made by the fuser and by design to keep the paper from curling up. The 4100 fuser applies a lot more pressure between the fuser film and the lower pressure roller. So much so that paper exiting the fuser would naturally want to curl up. Anticipating complaints, HP put four crease marks lightly into the paper that ran from the top of the page to the bottom which seemed to fix the curling problem. The reason for the added pressure between the two rollers is due to the size of the ceramic heating element. The larger heating element requires a softer lower pressure roller and increased pressure so paper would be exposed to all three elements. Looking at Figure 2, note the greater width of the 4100 heating element as compared to the one in the 4000. Also pictured is the increased size of the lower pressure rollers compared to the 4000 version. Technically, the creases were made by the fuser delivery rollers as can be seen in figure 3. The delivery rollers on the new 4100 fuser no longer contain these crease makers. Apparently the paper curl issue was not as common as first thought.
