## The AN/GRC-106

### History & Characteristics

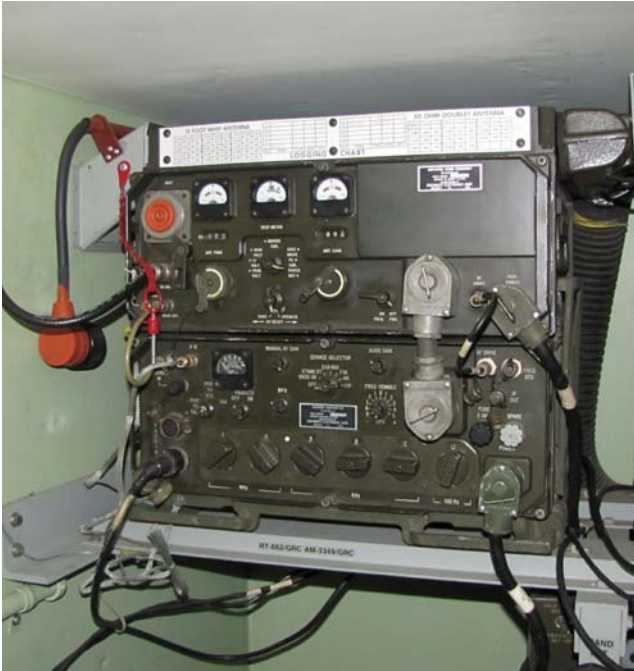
The AN/GRC-106 was developed in the early 1960's as a replacement for the AN/GRC-19, a heavy auto-tune set comprising of the T-195 transmitter and the R-392 receiver. The "angry" 19 was AM voice and getting old, it was in its third upgrade, and only 100 watts. And, its frequency range was limited to 1.5 to 22 MHz whereas the '106 is 2.0 to 29.999 MHz. The military saw the benefits of SSB and solid state construction and ordered thousands of these sets in the mid 1960's. They missed the mark on completely solid state however as the technology was not yet there so these sets do contain 5 vacuum tubes. Early sets were built using germanium devices, which were the common components of that period. The '106 is limited to USB only, many military sets are, as it simplified the set and there was no chance of the operator being on the wrong side band. The weight is still high at 120 lbs for the basic set, but better then the 260 lbs. of the '19.

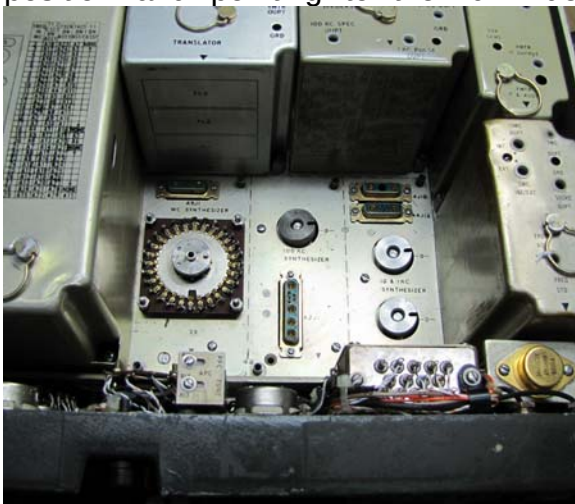
Next on the list are the 1A9, 1A2 and 1A4 modules. Any of these three modules may have similar problems so we will look at all 3 at the same time. These modules could have mechanical as well as electronic problems. So, assuming you are still powered up set your front panel frequency selectors to 15000(0) and wait for the turret to stop. Then shut down and remove power. Take a look at the mHz window on the 1A12 turret cover. It should say 15. If not, you have a gear train problem which will require further investigation and in-depth repairs. If OK, get a Phillips screwdriver and remove all three of the modules mentioned. The pins and slots of the drive couplings should all be at EXACTLY the 3 o'clock position and pointing to the "0" index mark. This is shown in figure 3.

If not, get a .050 Allen wrench and adjust them. If OK, turn over the modules and make sure each module's pin or slot is also pointing to its "0" index mark

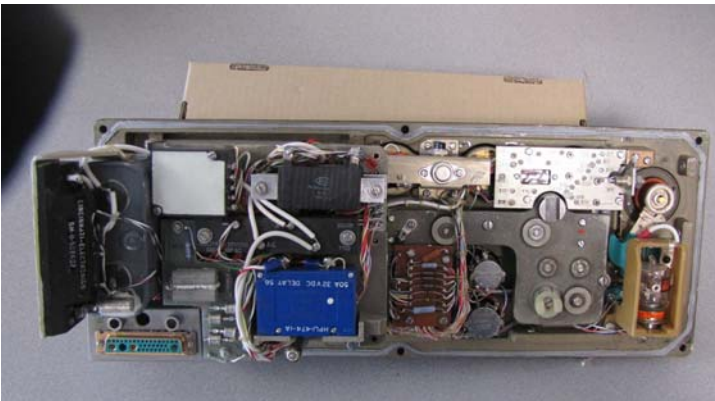
In the 2A1 front panel is the main power supply for the amplifier, the DC-DC converter. This supplies the low and high voltages for the 2A8 driver and the final tubes. In this converter, there is a pair of large high current stud mount transistors in a multi-vibrator circuit. These are usually, but not always, 2N5250's. The transistors often fail if a serious fault occurs in the amplifier, or high temperatures occur due to a blower failure or air restriction. If improper tuning is continuously used, these transistors may not last as the over current protection is not fast enough to prevent surges. Replacing these is not the easiest thing you will ever do but it is possible as I have replaced several. The manuals will guide you through disassembly of the front panel and transistor location. A bigger problem is finding replacements as they are obsolete and only available in large quantities from commercial suppliers. When the transistors were replaced in the depot, both were replaced but in my experience just exchanging the defective one worked fine as long as it is the same type. If one of these transistors failed, the 2A1A5A2R1 and R2 current limiting resistor for the associated transistor may also be defective so check it too.

Some less common items to fail include the main circuit breaker not resetting, shown in Figure 7, the “whip/50 ohm switch” on the 2A1 front panel, the power relay 2A1A2K1, defective “tune and test” meters, and the 2A7 relay module. Zener diodes 2A1A1VR1, VR2 and VR3 also have a high failure rate due to the high voltage and heat sinking.
