Project 2. Full restoration of an AVO Mk4 tube tester

Grid Voltage error (Repair)

REPAIR PART FINISHED - NOW COMES THE VERIFICATION This tester is so precise, it will outdo the Amplitrex AT1000

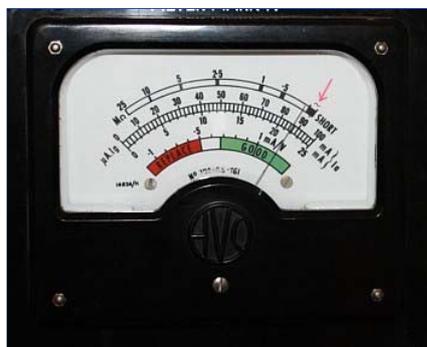
It didn't work. The calibration mark could not be reached with the SET~ switch now. I could only reach it I set it back to 190..210V. So what did this stinky seller do.... he just set the tester for 190..210, and that way, with 230V he could force the needle to the Calibration mark. Thus "fixing" the problem with the non-working mains calibration.

Look at this picture. This is as far as I could get it, with the SET~ switch all to the right. This may mean, one of the three transformers are damaged, but I was lucky, they were still fine.

Then I put in a calibrated Moving coil meter in series with the meter, and the problem got clear. The meter needed 35uA for a full scale, and it is a 30uA meter. An AVO is really only precise when all things are within tolerance, and there is no way to work around. So if a resistor is 10k+/- 2% there is no need to have a 1% resistor, but don't try it with 3% if you want the whole tester to be accurate. The most amazing thing is R36, which must be 200Ohm +/- 0.5%. I tried it, and adding in parallel a 20k resistor to R36 will reduce the meter reading with 5%. So for this resistor I am going to do a "zero" percent calibration. More about this later. R36 sets the internal impedance of the tester, and messing around by the previous owner with it was part of the dirty job by the seller of the tester. More about R36 later.

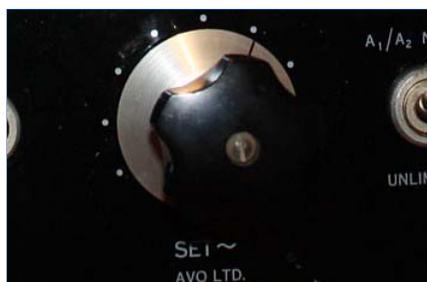
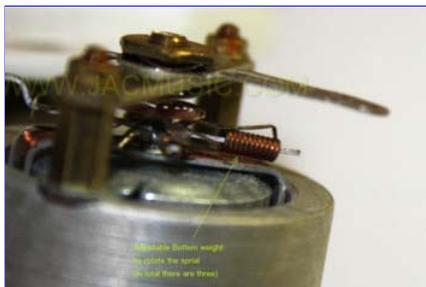
The whole inside was tweaked and changed in some attempts to increase the sensitivity. Unfortunately things don't work that way, and he gave up on it, leaving behind the meter as is. To get the tester "repaired" still, the seller just set the tester to **190..210V**, and of course now at **230V** you can reach the calibration mark easily. So that's what he did. Now all voltages inside were too high of course. He messed around with all other calibrations points inside, even messed with the factory calibration, that you are not supposed to touch. Somehow he managed to make the tester "acceptable", and ready for sales. That's when I bought it.

The meter was damaged by over current. Other as what many think, this will not burn the coil. You can not burn a coil with 300uA, though this is 10x more current than normal. 300uA is not enough for developing any heat, but there will be another kind of damage at 300uA: This will violently hit the needle against the end of the scale, and this will deform the coil. Specially since (very often) the electrolytic meter protection capacitor has gone high impedance over the years. Such deformations can be seen easily seem under a strong lens, and fixed perfectly, since the coil is very soft, and becomes trapezoidal shape. This is really easy to correct, when the coil is removed. All it needs to be is a square shape again. However, it requires complete complete desoldering of the hairsprings, re-adjust the pivot jewels and re-build the whole meter in fact. It's not very difficult, but you can do things wrong very easy, and the meter is gone.

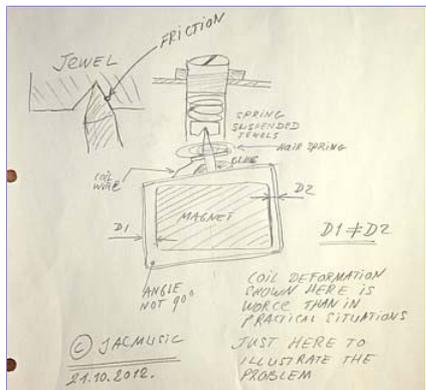
Sorry for the hand made sketch, but this shows best where the friction comes from. The jewel-needle joint is in reality much finer than drawn here.

Also one of the pivot jewels had jumped out. That is normal when the meter is badly unbalanced, the side fore on the jewels becomes too high. These are pretty large size, and can easily be removed. I took the opportunity to clean them also. The previous person put oil on them, but this is wrong. The oil will give capillary problems, and if adjusted well, there is no friction anyway, since a well balanced needle is suspended by the hair springs mainly. The jewels have almost no force on it, and no friction at all. Anyway, the attempt to oil them, tells me, he was aware of the friction.

A badly balanced coil has side forces on the jewels, which depend on the angle, and this gives the infamous scale nonlinearity, and friction. Mmmm it's really as easy as that, but you do need to practice a little bit on some old meters, that you would not need any more. The Ebay price of a new meter is 450 Euro (yes!). So better not damage your meter, and you can praise your tester when you have a perfect meter inside.

Balancing of the meter. If the coil is nicely in shape, it moves in the middle of the magnetic gap, regardless the rotation angle. This is elementary for good linearity, together with balancing of the needle for vertical operation. I was able to re-adjusted the coil's shape nicely symmetrical again, so original shape, and the meter is almost in balance again. Final balancing needs to be done still.

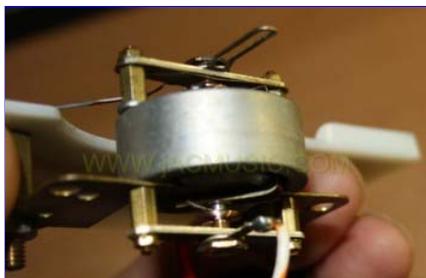
First, without the circular pivot springs, you have to set the pressure force on the sapphires, such that friction is close to zero, yet the coil is stable in place. This is a balancing act, you can only do without the pivot springs. So you need to find exactly that point where friction begins, and then re-adjust just that tiny fraction below it. The needle as you will see now has a small play, like approximately 0.2mm at the end of the needle tip. It's a little bit like a rattle, when you shake it. It's just this fraction of play you need, and this means the axis is caught by the jewels, but without pressure on it. Once the springs are in, the needle will be better fixed more tightly, since they give hold in all directions. (Not just circular, but vertical also)

Next is to balance the needle, still without the hairsprings. In the upright position, it "fell over" to the right when it was above 70mA on the scale. It fell by itself to the end of the scale. It is interesting to see with how large force the needle falls over. It sort of really falls over. So nonlinearity resulting is probably a lot. As you can understand, it is just THIS effect causing nonlinearity. So if the meter is indicating "70mA" on the scale correct, it would indicate "100mA" on a lot less than full scale.

If the balance is good, you can tilt the meter forwards or backwards, and tap it, and the needle may not move, yet if you do move it by hand it has zero friction. So this is without the pivot springs. You out the needle in any RANDOM position, and then you hold the whole meter in and random position, and the needle will not move. Now is so, the meter is balanced.

If done, very gently tape a construction on the scale of some thick paper, to hold the needle at zero, yet not bend the needle in any direction. Now, with the meter in the normal use position (for AVO Mk4 that is upright) solder the pivot springs back in.

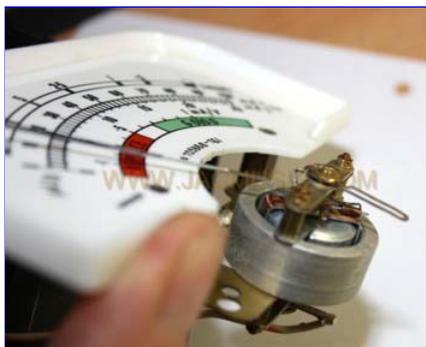
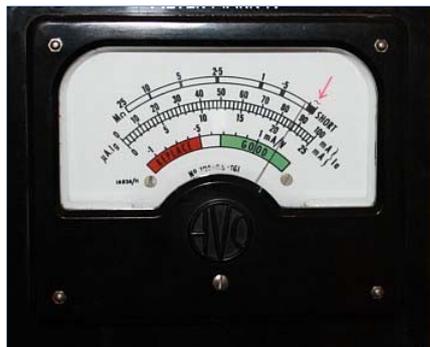
I checked now the Ohms Meter function of this tester. It was excellent. I Just put back in the same picture here. The tester has a 50 Meg Ohms Meter, which is the outer scale. It is used when you set it on leakage. The scale stops at 25Megm but if you look carefully, you can estimate a 50 Megs reading. Normal multi meters work with a 9V battery, but this one here works with appr 220 Volt DC. Which you need indeed, because leakage, corona, creepage, all these things appear at high voltage and hot filaments. To test it, just connected a know resistor from the A1 link to the and A2 link, and on leakage "A1" and "A2" you must now measure this resistance value EXACTLY. If not, you have more work to do.

The highest precision resistor I have is 10 Megs. The needle comes exactly on "10". PERFECT. This proves many of the inside circuitry to be good now, including the meter. Though the meter has to be tested as a separated unit also.

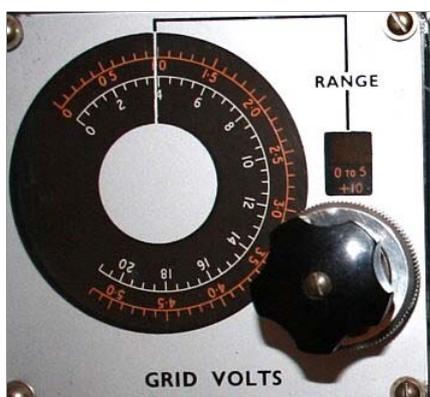
Now comes the grid voltage repair. With this setting, there is a small overlap with the settings wheel. So when the range is: 0 to 5 (+10) as picture here, you can set it from 10 to 15 Volt on the red scale. The next higher range is 0 to 5 (+15). so you can set it from 15 to 20 Volt.

TEST: You can set 15.0 Volt with either scale, and the reading on the panel meter must be fully identical. Also when you flip from the red to the white scale. Any differences can only come from the resistor divider network, the pot meter linearity, and the mounting of the dial wheel to the pot meter. This mounting is a permanent factory calibration.

It didn't work. Obviously the factory setting had been changed by the seller, the reason I found. One of the resistors in the divider network had been overheated and the paint was a bit burned. The seller discovered this as well, because this resistor had been cut loose with one end, to measure it. So did I, and it was 4% off, instead of maximum 1%. The seller just left it in. He must have seen the paint burn, but he must have thought 4% deviation was fine, not checking the tolerance from the manual. Or not have a 1% ohms meter. Whatever the reason, he left the resistor in, and instead choose to screw around with the factory calibration. This is the position of the dial wheel on the potentiometer. I use [this table](#) I made myself to check it. I do the calibration with a scope, this is more precise as the procedure in the manual. Whatever your choice, if you use the Excel table, whatever setting on the "Grid Volt" is must produce this, and if not there is work to do.

After this comes the calibration with the pot meters at the side. That is the user's calibration, not the factory calibration. Mind you, the previous owner has been screwing around with the factory calibration.

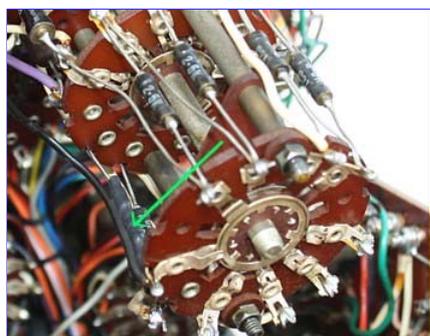
Here you see a black shrink sleeve, and inside is a selected array of metal foil resistors, which together have exactly the required value if 2500 Ohms +/- 1%. I think like this it looks nicely as original. All others resistors of the grid voltage switch were still excellent. So this is MOST likely how the meter got damaged, by a tube with a grid to cathode short circuit. You can discuss about it, if this is a tester's failure or an operator failure. Probably they skipped the "shorts" test. It is just this, what AVO is warning against. Anyway after replacing the resistor, it was more needed than before to do the factory calibration. The best way is by an oscilloscope, which is better as in the service manual. After checking another Mk4, that was never worked on, I found how to select the set points. It was kind of obvious. The service manual explains how to use a voltmeter instead, which is easier to do, but will not give the same nice result. After this was done, the Vg dial performed EXACTLY as expected. Now when I set 15V on two of the scales, the meter reading is identical. It was the wrong reading, but at least identical, and it was so for all (nine) scales like this. Another step forward :)

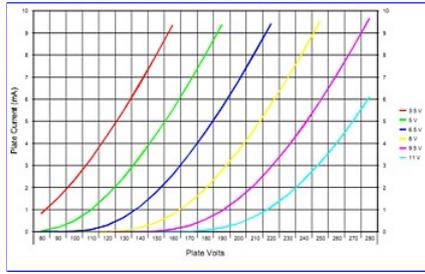
So we are going to need the values at 150V, 200V and 250V, and check a few grid lines. You can click on the curve to see the details. As you can see, this AVO Tester reproduces the Amplitrex AT1000 values. What is interesting the grid voltage of the Amplitrex is given with less resolution as the AVO. The Amplitrex will jump from 3.5V to 3.6 (lack of resolution) whereas with the AVO you can at least estimate on the scale the distance between 3.5 and 3.6. So you can read 3.55 from the AVO scale.

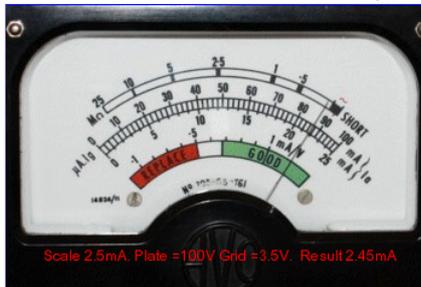
Scale 2.5mA, Plate =100V Grid =3.5V, Result 2.45mA

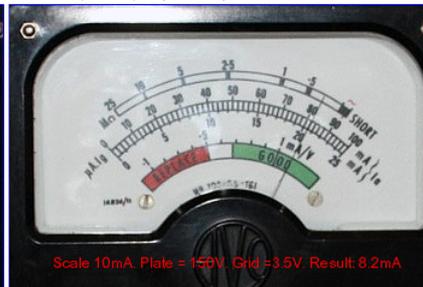
Scale 10mA, Plate = 150V, Grid =3.5V, Result: 8.2mA

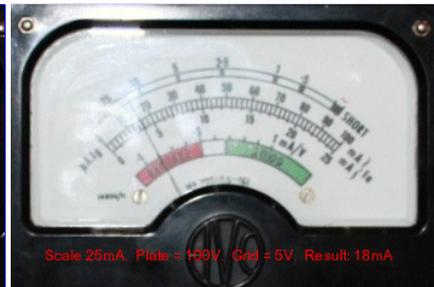
Scale 25mA, Plate = 100V, Grid = 5V, Result: 18mA
