Radford MA-25 - Early version - GZ34 rectifier,  
S/N 6310225 - cathode bias 470Ω resistors.

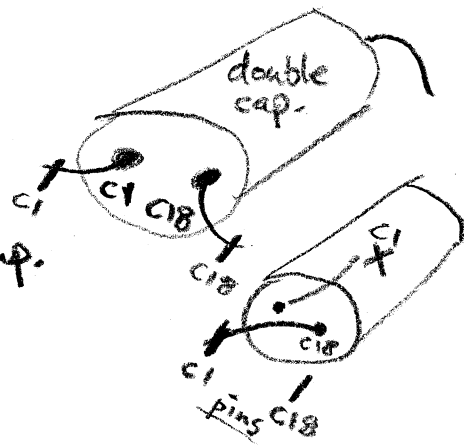
- Electrolytic capacitors slowly reformed. 2 weeks.
- Transformers dehumidified (8 months!)
- Amplifier working 100%.
- KT88, GZ34 test as new, KT88 superbly matched.
- KT88 both draw about 77mA. (37V across 470Ω res.)

Full Power Test 25W RMS (40V Peak-Peak sine) 8Ω.  
20Hz — 20kHz clean sine wave 25W RMS  
10Hz is good at 3 watts. 30W clipping

High freq. rolloff - 3db 45kHz @ 6 watts  
- 6db 80kHz

Gain: 0.5 volts input gives 14 volts out. 25W @ 8Ω

- \* Capacitor C1 was short circuit  
It's twin, C18 is OK and not used in amp.  
- So C18 has been connected as C1
- \* Amplifier requires jumper plug to switch 'on'. (remote on/off feature)
- \* Electrolytic caps are 60 years old!  
- and could fail at any time.
- \* Amplifier should be described "for restoration, as-is, tested as working well but could fail at any time!"
- \* Put some CRC on main capacitor skin? (corroding on top...)
- \* MAIN: Output tx good, mains TX good. Values good.  
Sold as is for restoration.
